Towards a fragility assessment of a concrete column exposed to a real fire – Tisova Fire Test

David Rush^{1*} and David Lange²

ABSTRACT

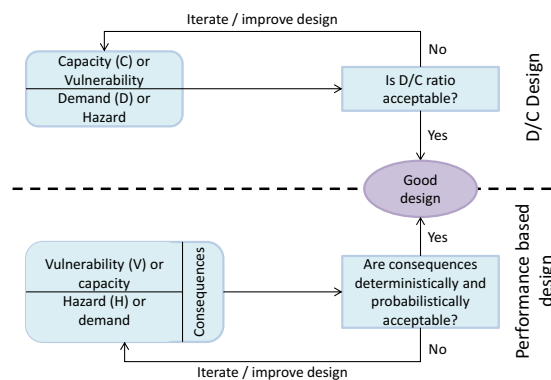
Figure 1: Demand capacity versus performance based design

This pass / fail assessment may also be referred to as demand / capacity based design, although when analytical or numerical tools are used in structural fire engineering it is often referred to as performance based design. This is not necessarily consistent with, e.g. earthquake engineering, as discussed above, where the consequences of an event outside of failure of a structural element are considered. The difference between demand / capacity and performance based design in earthquake engineering is shown in Figure 1 (modified from [12]). Both approaches are based on an iterative approach. In demand / capacity design the iteration is based simply on a comparison of the load on the structure and the capacity of the element. If the structural elements capacity exceeds the demand placed upon it then it is deemed to satisfy the design criteria, if not then an iteration loop is performed to evaluate an element with a higher capacity. In performance based design there are two concepts added to this iteration process, consideration of the consequences of the capacity not meeting the demand (for example in financial terms or in terms of ‘downtime’ of the structure), and the possibility to address both the response and the consequences in a non-deterministic way. Put simply this means that although an element of structure might fail as a result of loads placed on it, bearing in mind the infrequency of the event, and so long as the actual consequences are acceptable if they happen at this frequency, then the overall design may still be acceptable.

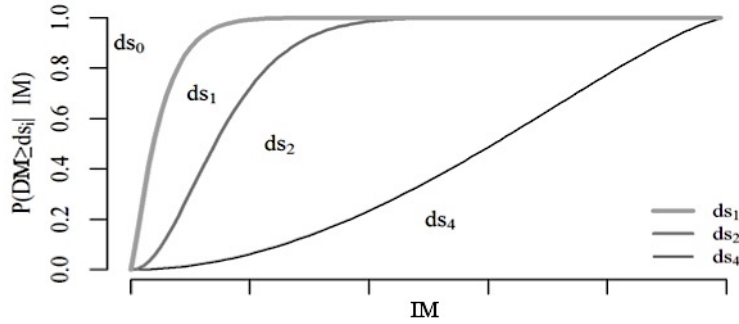
Figure 2: Fragility curve for a hypothetical 4-state damage scale ranging from no damage to structural collapse.

These two interrelationships (*IM* to *RM*, and *RM* to *DM*), when coupled, construct a set of fragility curves that correspond to discrete damage states included in a damage scale (see Figure 2). A fragility curve is a continuous fire intensity-to-damage relationship that expresses the probability that a building will suffer damage corresponding to a specific damage state for a given fire intensity measure. Symbolic fragility curves for a hypothetical 4-state damage scale are illustrated in Figure 2.

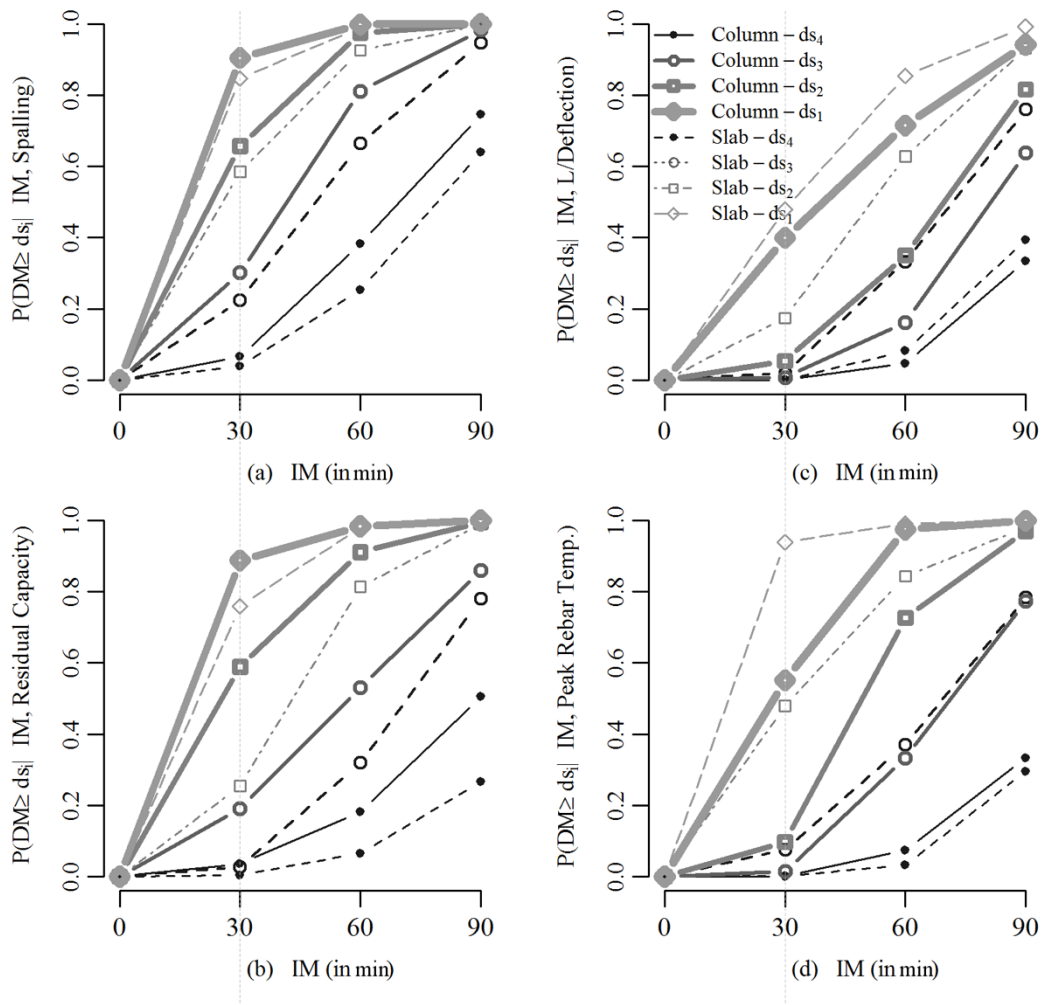
Figure 4: Fragility curves corresponding to three damage states for (a) spalling, (b) deflection, (c) residual capacity and (d) pear rebar temperature constructed for slabs and columns.

The fragility curves created, linking the intensity of a fire (in this case the equivalent time of the standard ISO-834 fire) to the probability of being within a certain damage state, can be seen in Figure 4 for each of the four response measures explored. For instance, for a fire intensity of the equivalent of 60 minutes of the standard fire you have, for spalling of a column, a 99% chance of being in at least damage state 1, a 96% chance of being in at least damage state 2, a 78% chance of being in at least damage state 3, and a 37% chance of being in at least damage state 4.

Using the quantified damage scale (Table 2) and the fragility curves (Figure 4), an analysis of a column exposed to a travelling fire will now be presented.

Using the fragility curves presented in Figure 4 and a measure of the intensity of the fire, it is possible to estimate the damage state that the concrete column is in. To generate a measure of the intensity the recorded time-temperature histories at the three depths below the soffit are converted in to equivalent areas under the standard fire curve based on three levels of equivalency being assessed; the total area under the curves; the total area above 150°C [26]; and the total area under the curve above 400°C [14]. The equivalent area concept is shown in Figure 3, and the values of the equivalent time under the ISO-834 fire [39] are presented in Table 3. These equivalent fires are applied as the measure of intensity within the fragility curves (Figure 4) from which the likelihood of the column being in one of the damage states can be assessed by reading the probability associated with a given damage state at that intensity off the graph. For example, for spalling damage shown in Figure 4 a), the probability of the column being in Damage State 4 at an intensity of 60 minutes is around 40 %; the probability of the column being in Damage State 3 is around 80 %; the probability of it being in Damage State 2 is ca.97 % and the probability of it being in Damage State 1 is almost 100 %. Table 3 shows for comparison the highest damage state, for each of the measures of damage, at the different intensities, for which the probability of the column being in that damage state is greater than 50 %.

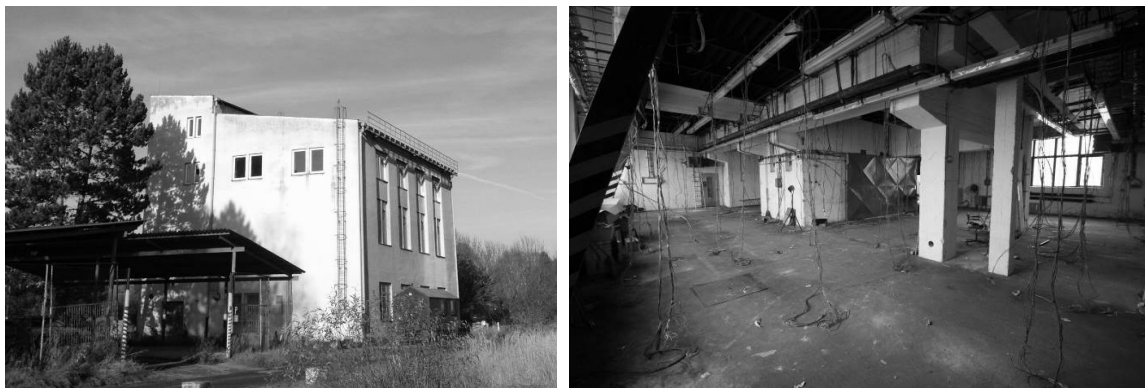
Figure 5: Left – Southwest corner of test building, and Right – fire compartment

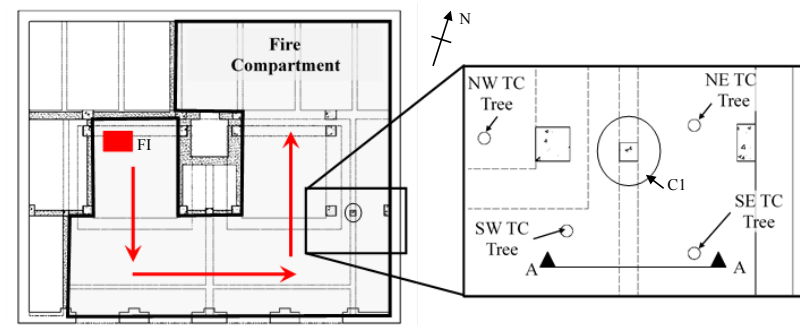
Figure 6: Fire compartment showing fire ignition point (*FI*) and path of travel (arrows), and column C1 and associated TC tree locations

The test compartment shown in Figure 6 was on the ground floor and the fire compartment had a total area of approximately $230m^2$ and was 4.4 m high from floor to slab soffit. The layout was generally open, with a series of large rooms enclosing one side as well as one corner. There was also a central lift shaft. Four columns were fully within the fire compartment. The smallest 30 x 30 cm column (C1) indicated in Figure 6 was chosen to be examined due to its slenderness and was therefore most likely to experience higher core temperatures and damage during the fire test.

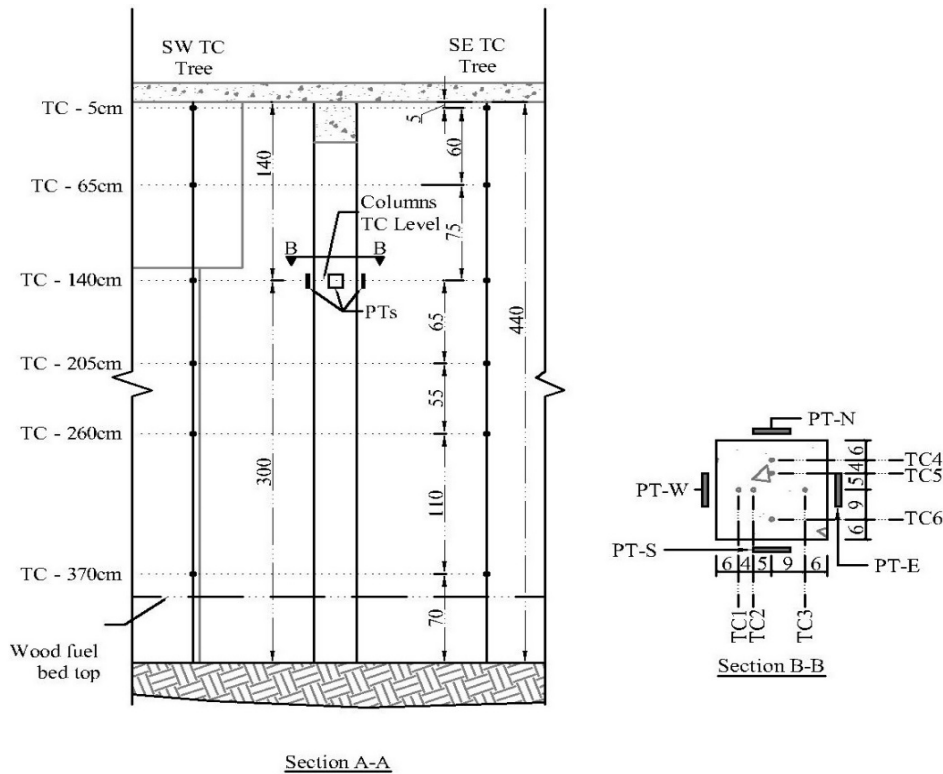
Figure 7: Section A-A: TC tree thermocouple layout, and column TC and PT height, and Section B-B: Column cross-section showing TC and PT placement

Column C1 was instrumented with a total of 12 thermocouples, 6 thermocouples positioned 1.5m above the floor and 6 thermocouples 3m above the floor, unfortunately the thermocouples 1.5m above the floor suffered from a failure early on in the test and all data was corrupted and will not be discussed any further in this paper. Figure 7: Section B-B shows the locations of the thermocouples at the 3m height of the column. Figure 7 shows four TCs which were placed 6 cm from each of the four faces, and two TCs which were placed 10 cm from the North and West faces. Holes were drilled at an angle of 45° from above to mid-depth of the columns and TCs were then temporarily held in position and re-cast into the column using quick setting mortar. A plate thermometer (PT) was placed 10 cm from each of the North (N), East (E), South (S), and West (W) column faces with their centres at the same height from the floor as the thermocouple ends as an indication of the fire exposure to the column at the 3m height.

The thermal boundary for the column at 3m above the floor was measured using four plate thermometers (PT) around the perimeter of the column (Figure 7: Section B-B). Figure 9 a) shows the recorded PT temperatures for the individual PTs and compares the average temperatures from the PTs to the average TC-140cm temperature data, showing a very good correlation between the two averages. Any future modelling of the heat transfer to the column can be confident of the thermal boundary present in the tests.

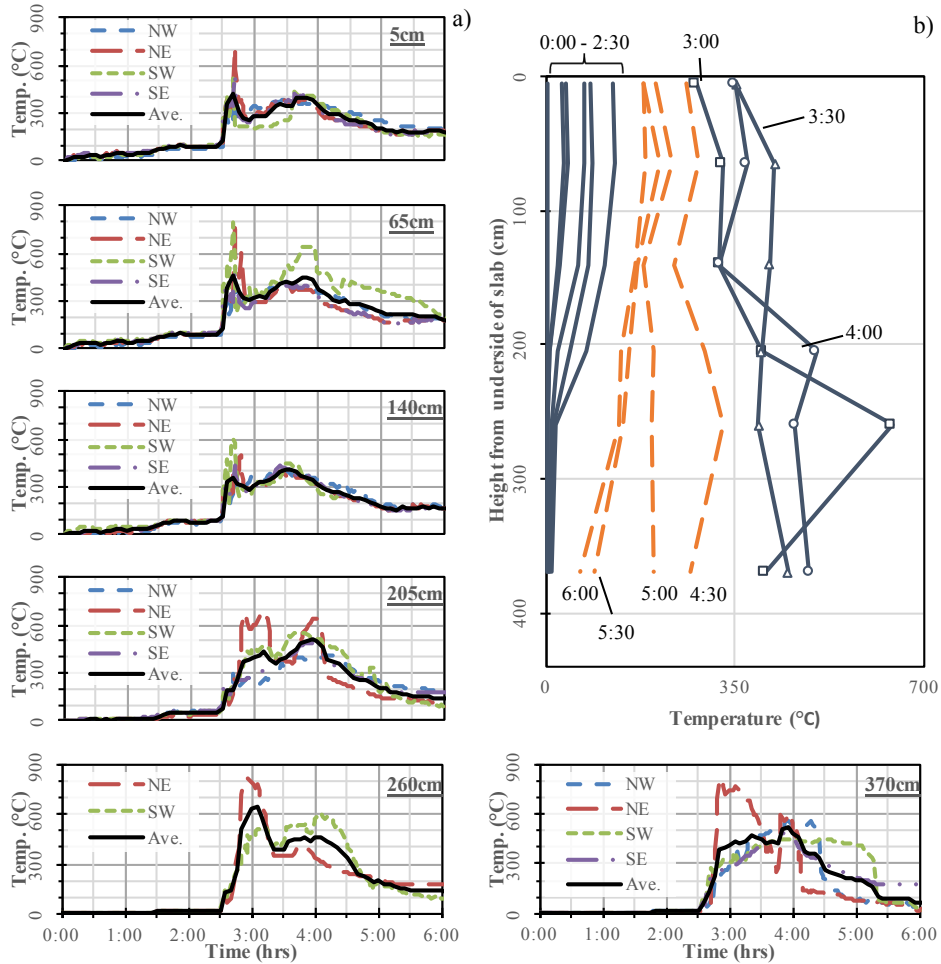
Figure 8: a) Time-temperature curves at each of the 6 TC heights below the soffit of 5cm, 65cm, 140cm, 205cm, 260cm, and 370cm; and b) variation in temperature over the height of the compartment at 30 minute intervals

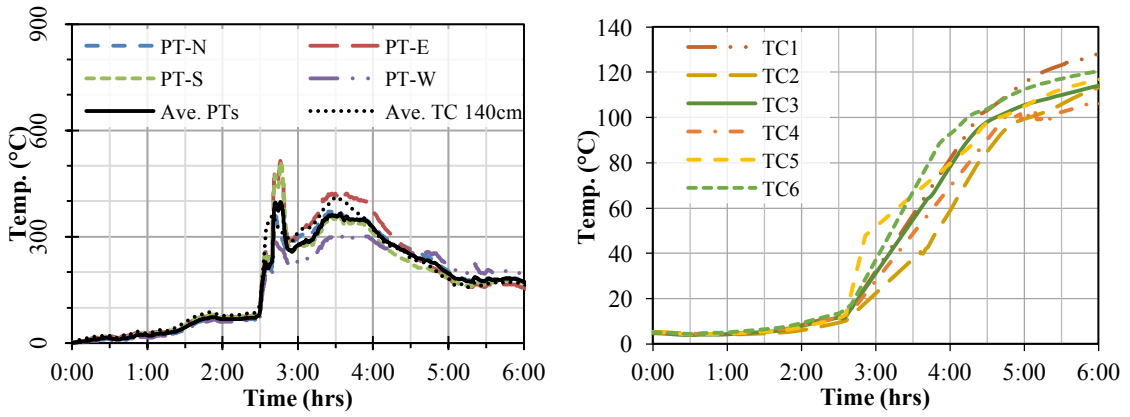
Figure 9: a) Comparison of PT and TC tree recorded temperatures at 140cm below ceiling soffit; and b) Recorded temperatures within concrete column C1

As previously stated, unfortunately temperatures at 1.5m above the floor failed to be recorded, so comparisons of the heat transfer to the column from the more severe temperatures recorded within the lower half of the compartment to the cooler upper half cannot be made. However, Figure 9 b) shows the data recorded at 3m above the floor (1.4m below the ceiling), and shows an increase in structural temperatures at around 2:40 which increase relatively linearly until 4:30 at approximately 1°C/min. The very slow heating rate causes very similar temperatures to be observed within the cross-section.

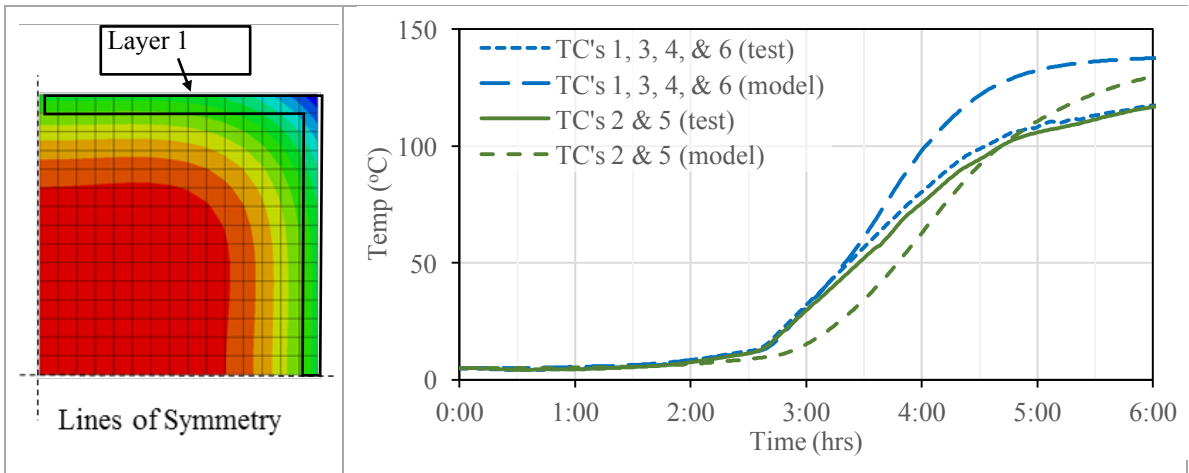
Figure 10: a) quarter cross-section of column at 6hrs of heating; and b) comparison of modelled and recorded average temperatures within cross-section.

Initially the concrete cross-section at 140cm below the slab soffit was modelled using ABAQUS, employing thermal boundary properties ($\epsilon_{\text{tot}}=0.7$, $\alpha_c=25 \text{ W/m}^2\text{K}$) including the recorded temperature history, and concrete thermal properties mentioned previously. As can be seen in Figure 10, the modelled temperatures are in general slightly greater compared to the averaged recorded temperatures. The average error over the 6 hours is -2.3°C and $+8.6^\circ\text{C}$, with maximum absolute errors of 17°C and 25°C , for TC's 2 & 5 and TC's 1, 3, 4, & 6 respectively. These relatively small errors are likely due to inaccuracies of retrofit placement of the thermocouples within the column and modelling a 3D environment in 2D. However, these errors are within expected levels experimental and modelling errors.

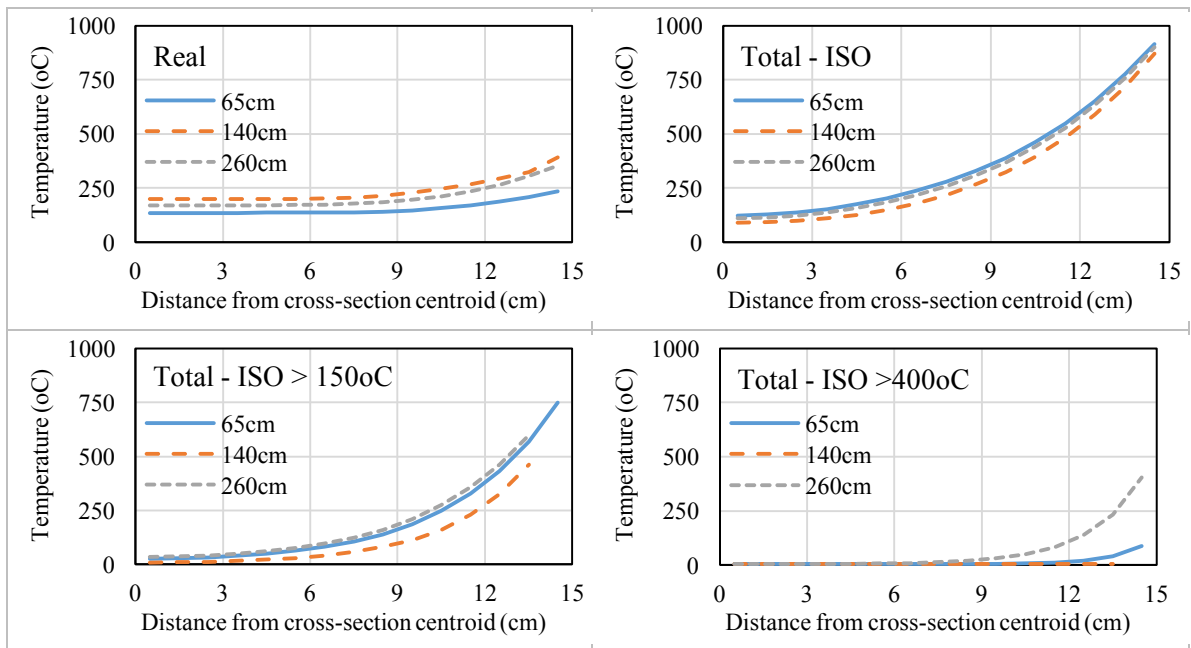
Figure 11: Maximum temperature profiles under real travelling fire, and equivalent times under the ISO-834 fire curve

Using the benchmarked thermal model, two subsequent thermal analyses assessed the thermal profile of the cross-section at the 65cm and 260cm depths below the soffit. The cross-section was also modelled to the three levels of equivalent times (see Table 3) under the ISO-834 time-temperature curve. The thermal response of the cross-section is compared in Figure 11 which shows the averaged maximum temperature at the centroid of the cells for each layer of cells at a perpendicular distance from the centroid (schematic shown for layer 1 in Figure 10 a)), determined using recorded thermocouple temperatures (Real) or equivalent durations of the ISO-834 fire using either the total area under the curve, area under the curve above 150°C , or area under the curve above 400°C . Figure 11 clearly shows that any of the equivalent area methods do not accurately predict the thermal gradients experienced within the concrete column when it is exposed to a travelling fire.
